WATER MANAGEMENT CASE STUDY

Company: HAYMSA

Location: Tarrasa, Spain

Type of site: Sand and gravel pit

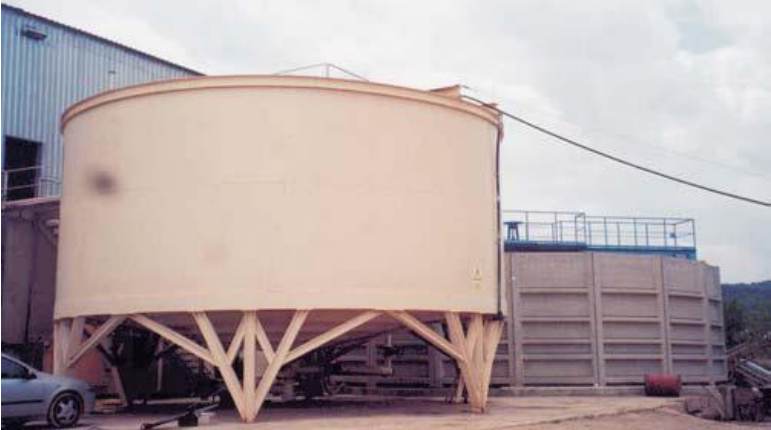
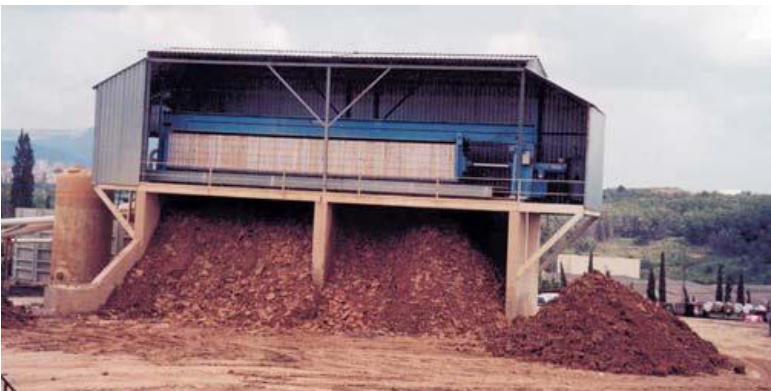
New water treatment cycle with thickener tank, settlement tank and press filter

Reduction of land occupation
Minimisation of water consumption due to the low water content in the clay of the press filter
Reduction of energy consumption
Elimination of the risk of spillage of water with solids and mud to public water courses
The final output of the press filter is a good material for restoration uses
