WATER MANAGEMENT CASE STUDY

Company: HAYMSA

Location: Tarrasa, Spain

Type of site: Sand and gravel pit

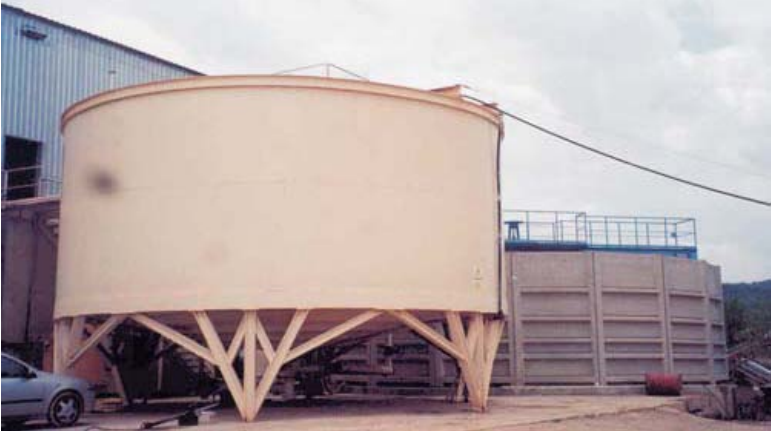
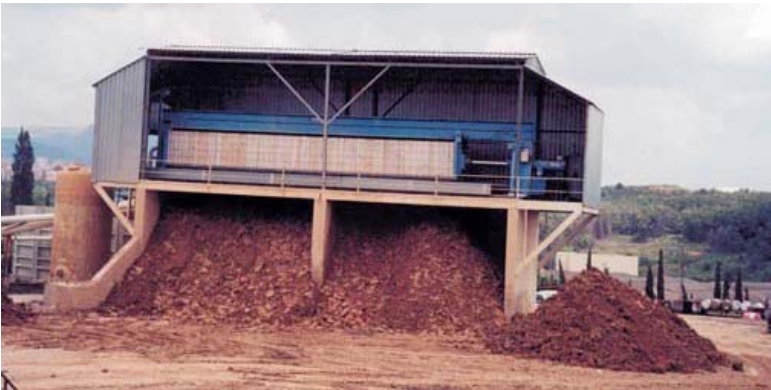
New water treatment cycle with thickener tank, settlement tank and press filter

Reduction of land occupation
 Minimisation of water consumption due to the low water content in the clay of the press filter
 Reduction of energy consumption
 Elimination of the risk of spillage of water with solids and mud to public water courses
 The final output of the press filter is a good material for restoration uses
