WATER MANAGEMENT CASE STUDY

Company: Tramsa

Location: Valdocarros (Madrid), Spain

Type of site: Sand and gravel pit

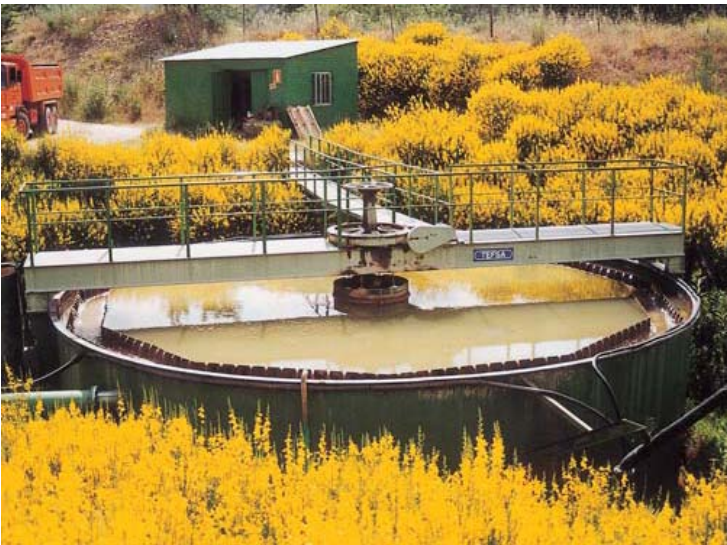
New water treatment cycle with thickener tank
Resulting mud is collected from the bottom of the tank and directly charged in a lorry with a tank and transported to restoration areas

Reduction of land occupation
Minimisation of water consumption due to the low water content in the mud
Reduction of energy consumption
Elimination of the risk of spillage of water with solids and mud to public water courses
The final output of the thickener tank is a good material for restoration uses
